Manhole Inspection Summary

Manhole # S27K__030MH

Insp Date: **6/4/08 1:15 PM**

Location Address: **921 Ryan St**

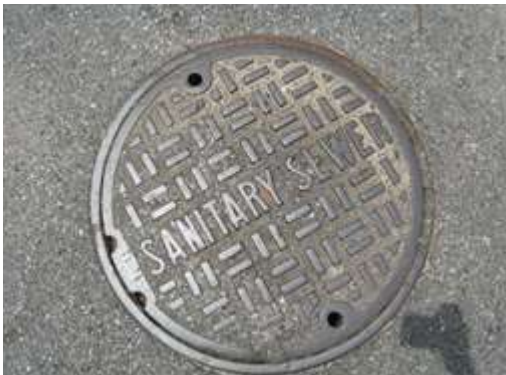
Cover View

Condition: **Sound**

Condition: ☐ Sound ☐ Cracked ☒ **Leaks**

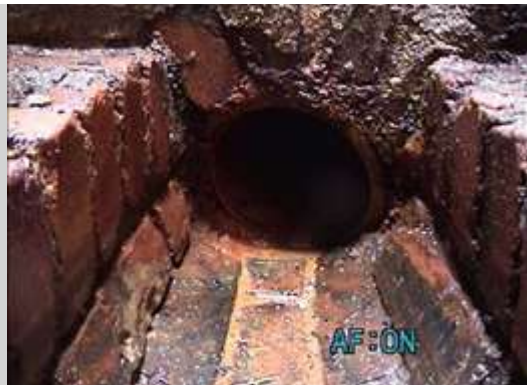
6 O'Clock Inflow

6 in. Circular Gravity Sewer
Pipe In @ 6 O'Clock

Pipe Height: **6** (in.) Rod and Bar (Angled)
Pipe Material: **Clay** ☐ Pipe Lined
Invert Depth: **9.38** (ft.) Flow Characteristics: **None**
Deposits: ☒ **None** ☐ Mud ☐ Sludge ☐ Debris ☐ Grease
Silt Depth: **0** (in.) Deposits Extent:
Infiltration: **None** Pipe Seal Cond: **Sound**
